SPIRE CENTER FOR PERFORMING ARTS

Plymouth, MA

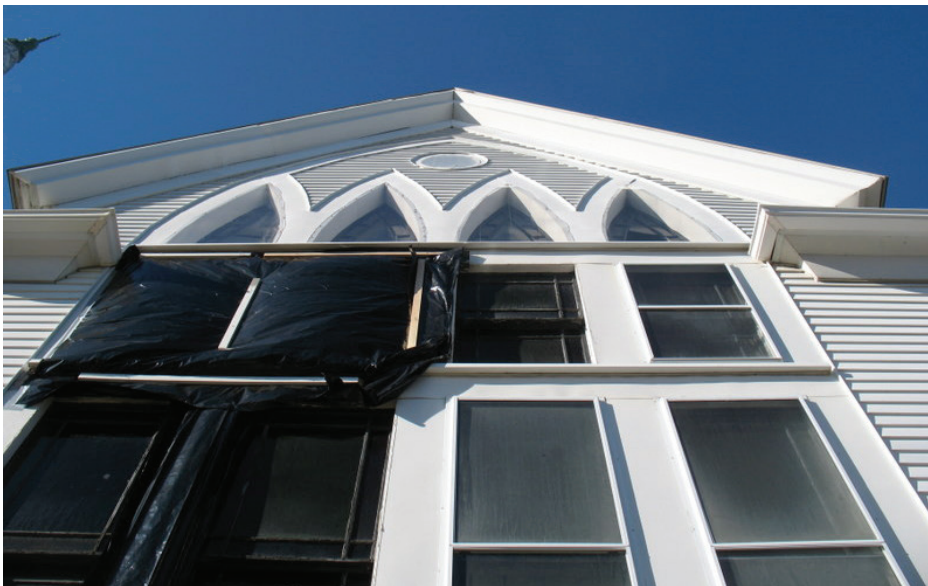
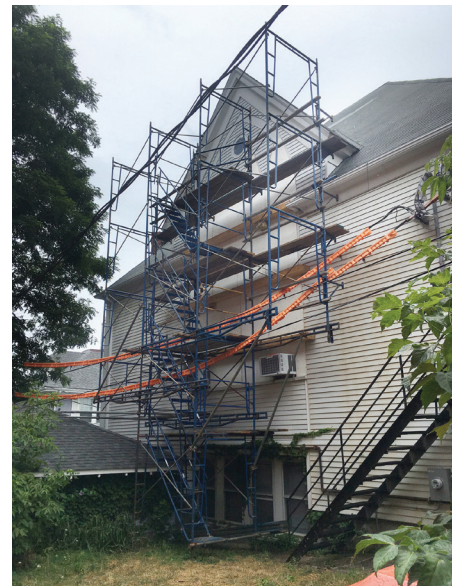
It is not uncommon for historical structures to create an opportunity for creative engineering, and the Spire Center is no exception. Located about a block away from Plymouth Bay, the Spire has seen its fair share of the infamous Nor'easters that New England has to offer. Built in 1886 as a Methodist Church, the Spire has withstood seasonal beatings for about 130 years. The age can be seen within the traditional post-and-beam construction, and so can the damage. From out-of-plumb walls to popping off of trim, the character of the building started to become a significant structural problem.

The initial work performed on the structure was to temporarily stabilize the window walls against further buckling. The damage was caused by a combination of thrust forces from the rafter eaves in significant snow load scenarios and the dynamic suction and positive pressure from the wind acting on the wall.

Once the temporary braces were installed, the attic framing was augmented to increase the capacity of the structure and redirect the load path to minimize the thrust loads that had been crippling the window walls below. The augmentation was performed by creating field built trusses in the attic and resolving the thrust loads into new steel tension rods that are hardly noticeable in the auditorium below.

Along with stabilizing the structure, a new limited use-limited application elevator shaft was installed to abide by ADA (American Disabilities Act) standards and create a more accessible structure. The next phase of the project will be to remove the temporary window wall bracing and install a more permanent solution.
