## RESIDENTIAL SHOREFRONT PROTECTION

Chatham, MA

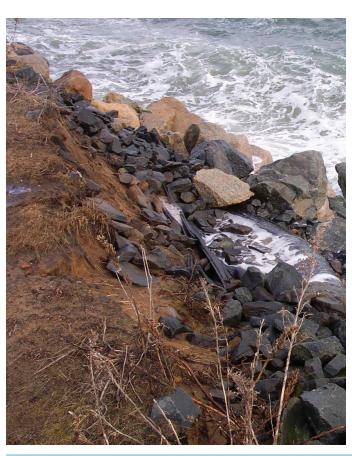
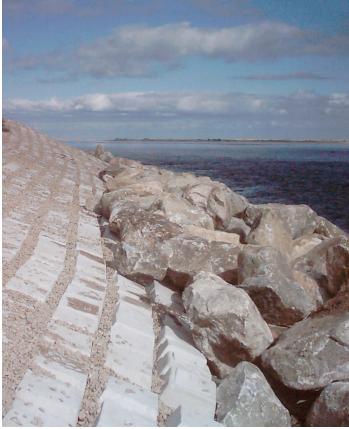
Due to drastic changes in the Chatham Harbor shoreline, the existing rock revetment on this shorefront property overlooking the harbor had deteriorated to such an extent that the revetment was in imminent danger of collapse — posing a potential threat to the safety of both the boats that use the channel and the existing house at the top of the coastal bank.

To remedy the situation, an immediate request for emergency repairs was filed with and approved by the local Conservation Commission. First, the armor stones on the lower sections of the revetment were stabilized. Next, the top section of the revetment was replaced with a new revetment design using concrete mats and anchors that were installed and "keyed" into the soil. Then, the replaced armor stones from the top section were added to the lower sections to further stabilize the entire revetment.

Once this construction phase of the project was completed, the area above the revetment — from behind the top rock apron to the sloped edge of the coastal bank — was re-vegetated with native grasses and salt-tolerant plantings.
